**National Highway
Traffic Safety
Administration**

ON-SITE AIR BAG INVESTIGATION

CASE NO. - 94-11
FLEET - RENTAL VEHICLE
LOCATION - [REDACTED] INDIANA
ACCIDENT DATE - [REDACTED] 1994

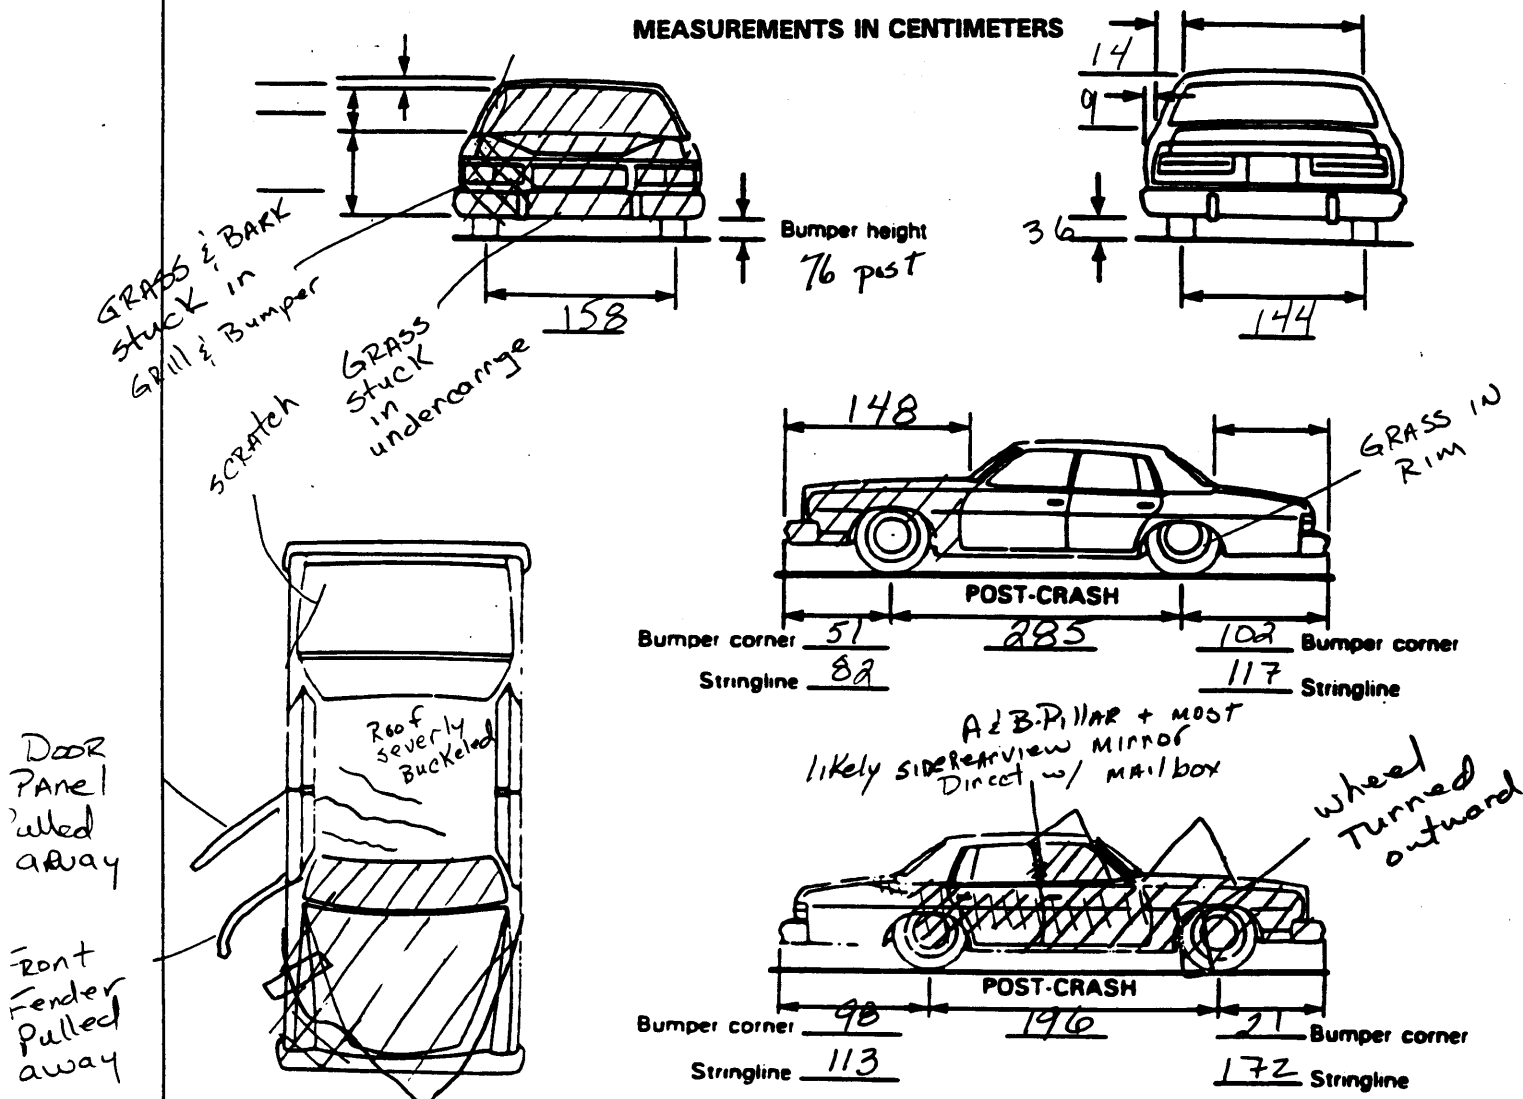
VEHICLE DAMAGE SKETCH

TIRE—WHEEL DAMAGE a. Rotation physically restricted RF <u>1</u> LF <u>2</u> RR <u>2</u> LR <u>2</u> (1) Yes (2) No (8) NA (9) Unk.		b. Tire deflated RF <u>1</u> LF <u>2</u> RR <u>2</u> LR <u>2</u>		ORIGINAL SPECIFICATIONS Wheelbase <u>266</u> cm Overall Length <u>483</u> cm Maximum Width <u>177</u> cm Curb Weight <u>1290</u> kg Average Track <u>147</u> cm Front Overhang <u>112</u> cm Rear Overhang <u>109</u> cm Undeformed End Width <u>156</u> cm Engine Size: cyl./displ. <u>3.1</u> L		WHEEL STEER ANGLES (For locked front wheels or displaced rear axles only) RF \pm _____ ° LF \pm _____ ° RR \pm _____ ° LR \pm _____ ° Within \pm 5 degrees	
TYPE OF TRANSMISSION <input type="checkbox"/> Manual <input checked="" type="checkbox"/> Automatic				DRIVE WHEELS <input checked="" type="checkbox"/> FWD <input type="checkbox"/> RWD <input type="checkbox"/> 4WD		Approximate Cargo Weight _____ kg

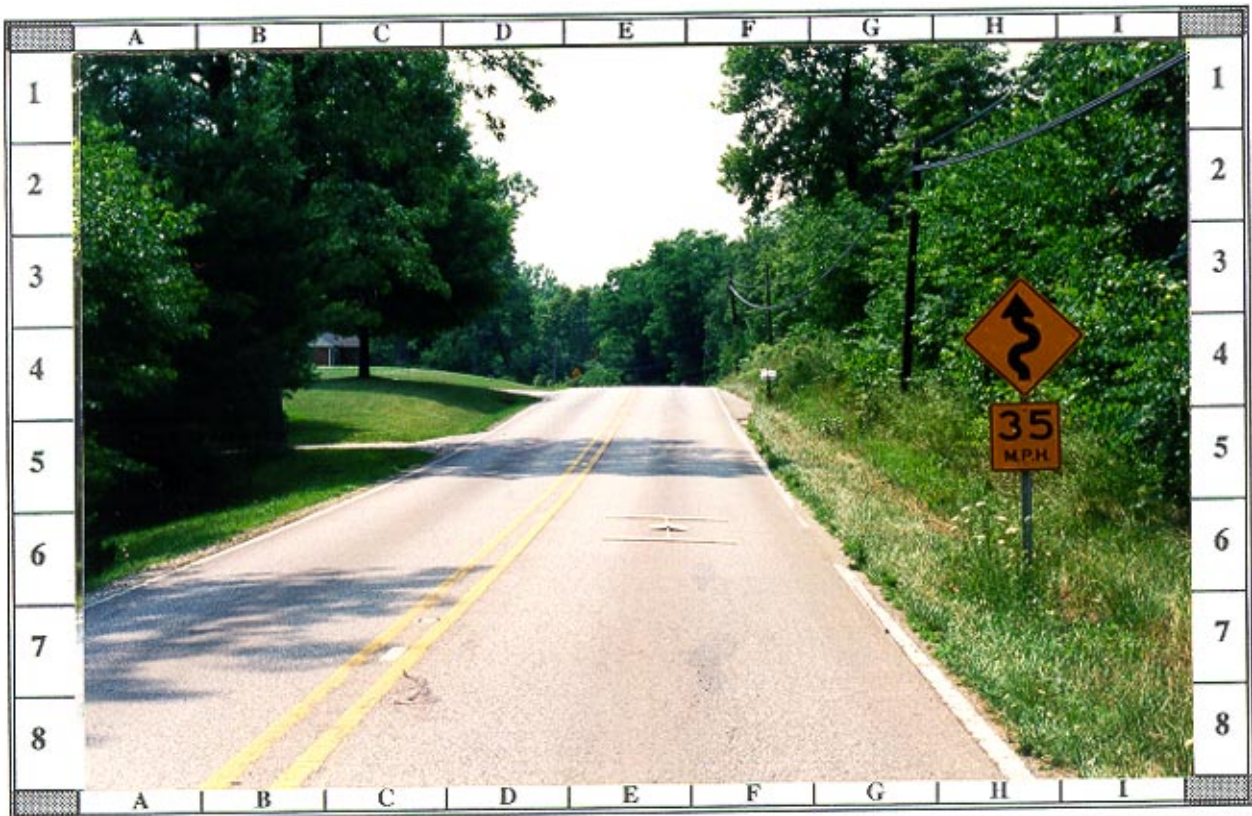
01 -- 1994 Oldsmobile Cutlass Ciera S's westward, uphill, path of travel approximately 70 meters east of first harmful event

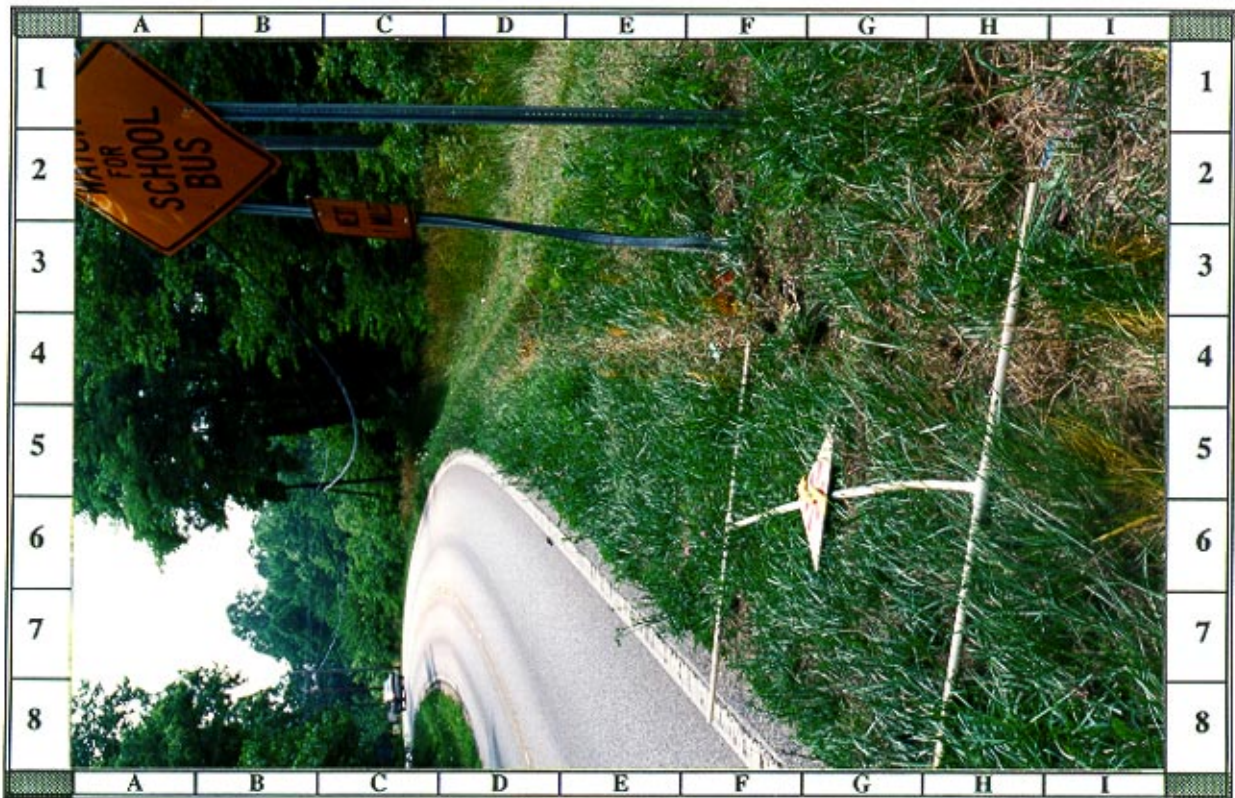
12 -- Close-up of 1994 Oldsmobile Cutlass Ciera's third impact with left sign post and subwarning sign (i.e., NEXT 1 MILE)

Event number:	Third
Object Struck:	Sign post and SCHOOL BUS subwarning sign
Damage location	
Damaged Plane:	Right
Vertical Location	
On Plane:	Midline between sill and just above beltline
Length Direct:	291 cm (114.6 in)
Direct Begins:	25 cm (9.8 in) rearward of right rear axle
Field L:	292 cm (115.0 in)
C₁:	Unknown²
C₂:	Unknown²
C₃:	Unknown²
C₄:	Unknown²
C₅:	Unknown²
C₆:	Unknown²
D:	-12 cm (-4.7 in)
Maximum Crush:	8 cm (3.1 in)
Location:	Right rear door/"C"-pillar area at beltline
CDC:	12-RZAS-1
Damaged Components:	Right: front and rear door panels, quarter panel, and rear wheel cover and rim

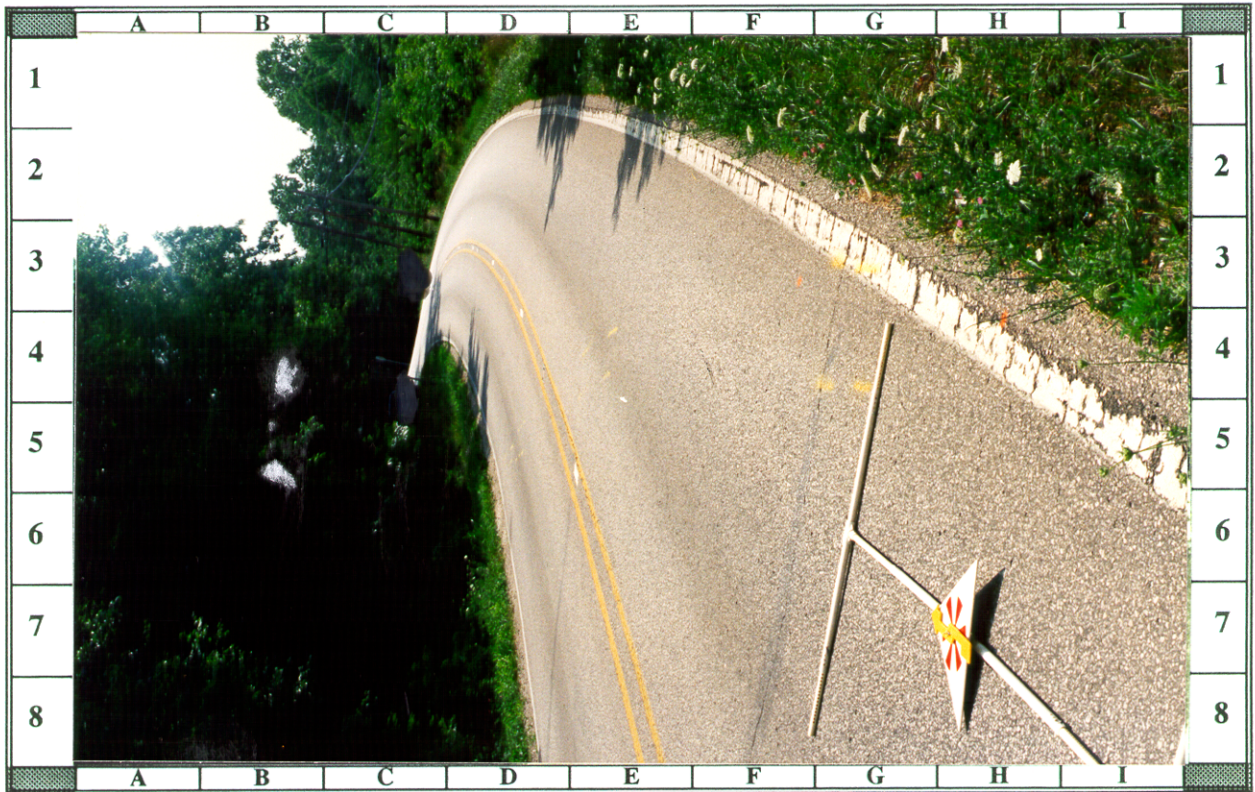
17 -- Close-up of '94 Oldsmobile Cutlass Ciera's tire marks on roadway from driver's oversteering (see cells D5, E4, and G4)

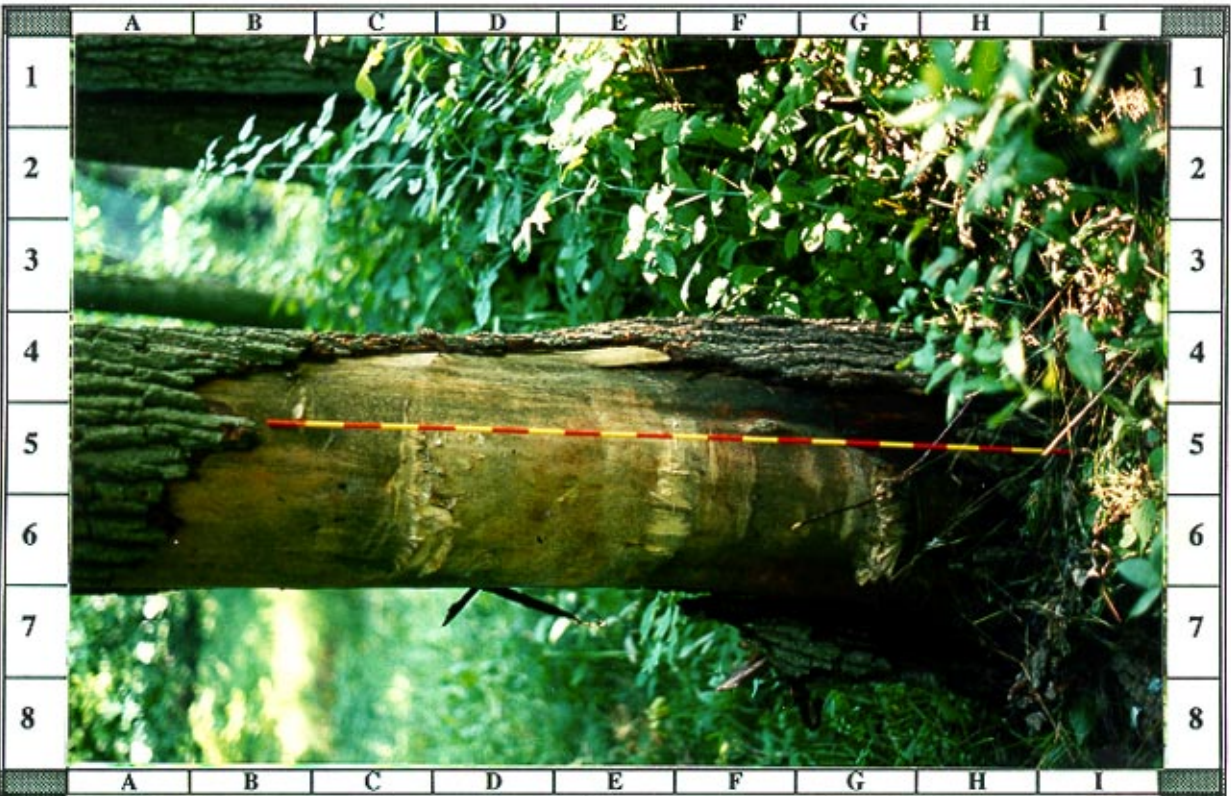
26 -- Close-up of large (~37 cm) tree impacted by 1994 Oldsmobile Cutless Ciera S; NOTE: distinct transverse tree damage

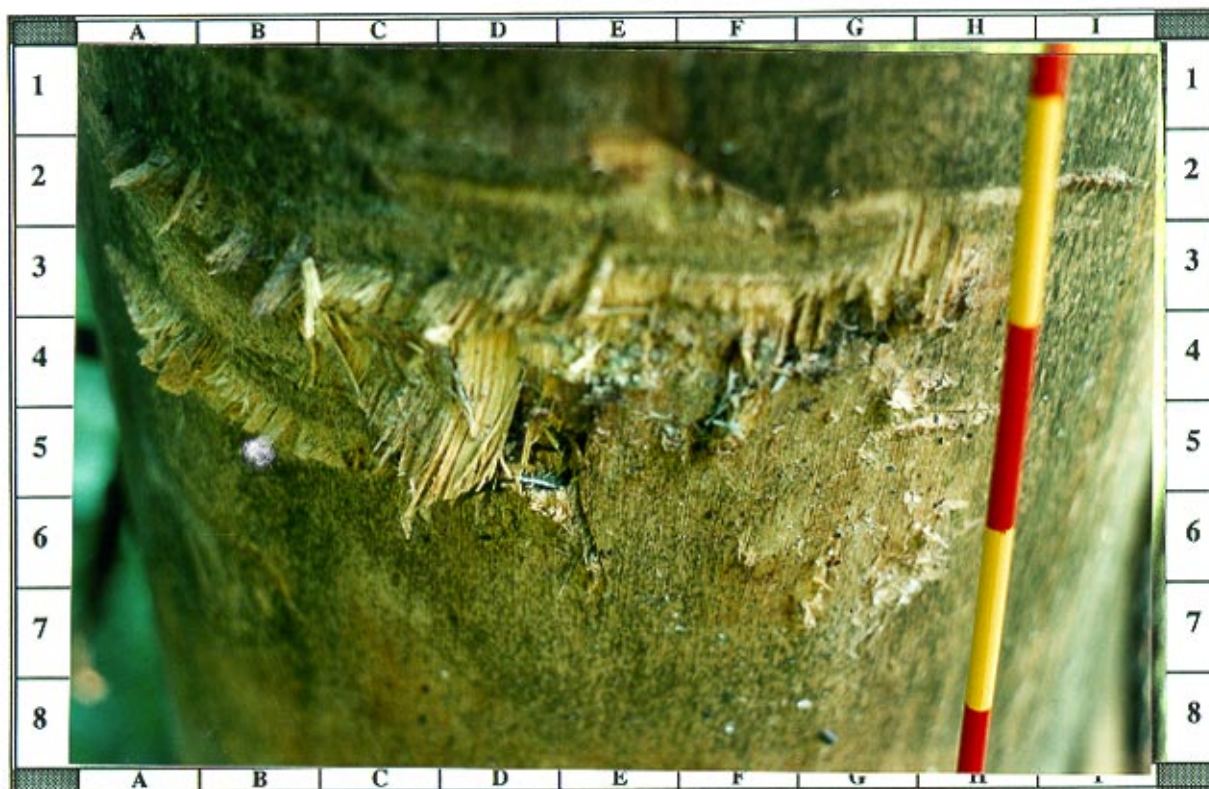
27 -- Closer-up of topmost transverse tree damage showing plastic and metal embedded in tree from impact with 1994 Oldsmobile Cutlass

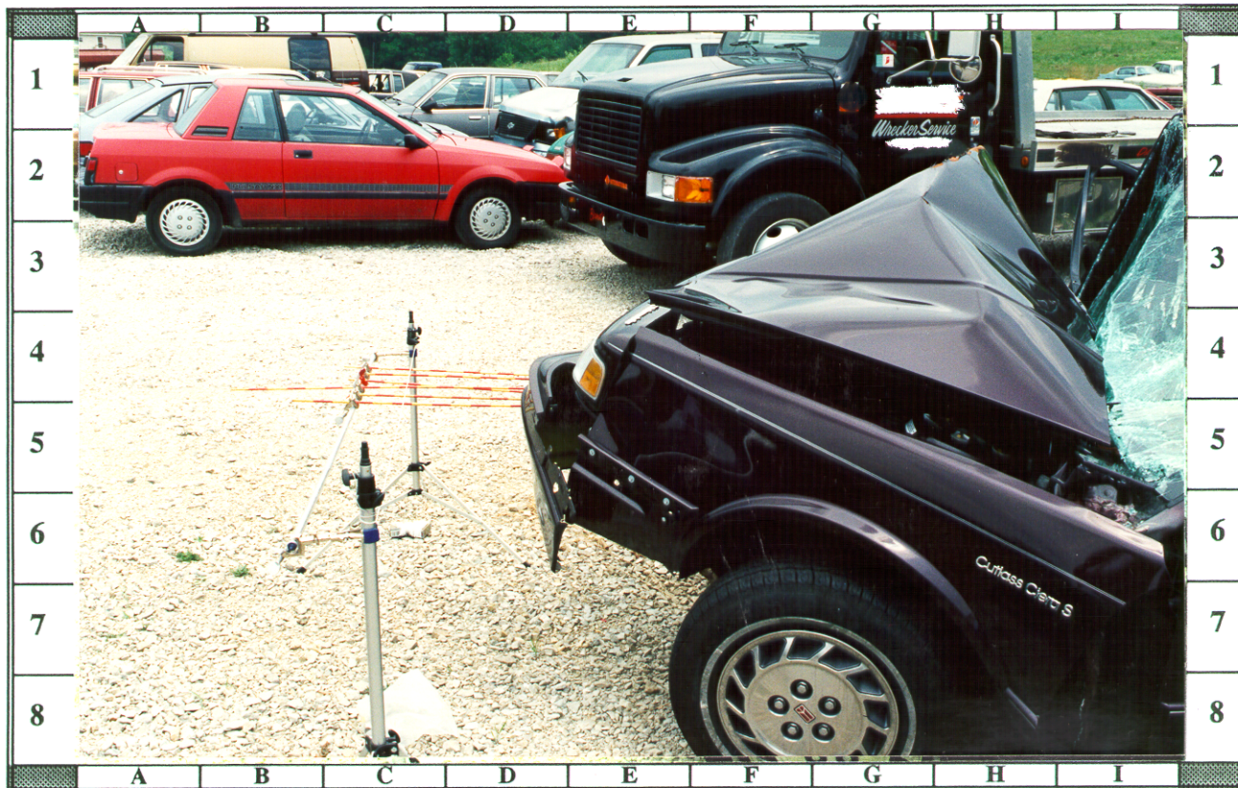
37 -- 1994 Oldsmobile Cutlass Ciera S's front crush with contour guage viewed across reference line from left

Event number:	Four
Object Struck:	Large tree [37 centimeters (14.6 inches)]
Damage location	
Damaged Plane:	Front
Vertical Location	
On Plane:	Bumper to top of hood
Direct Begins:	10 cm (3.9 in) in from right bumper corner
Length Direct:	42 cm (16.5 in)
Field L:	48 cm (18.9 in)
C₁:	18 cm (7.1 in)
C₂:	45 cm (17.7 in)
C₃:	64 cm (25.2 in)
C₄:	141 cm (55.5 in)
C₅:	139 cm (54.7 in)
C₆:	137 cm (53.9 in)
D:	+47 cm (+18.5 in)
Maximum Crush:	141 cm (55.5 in)
Location:	C₄

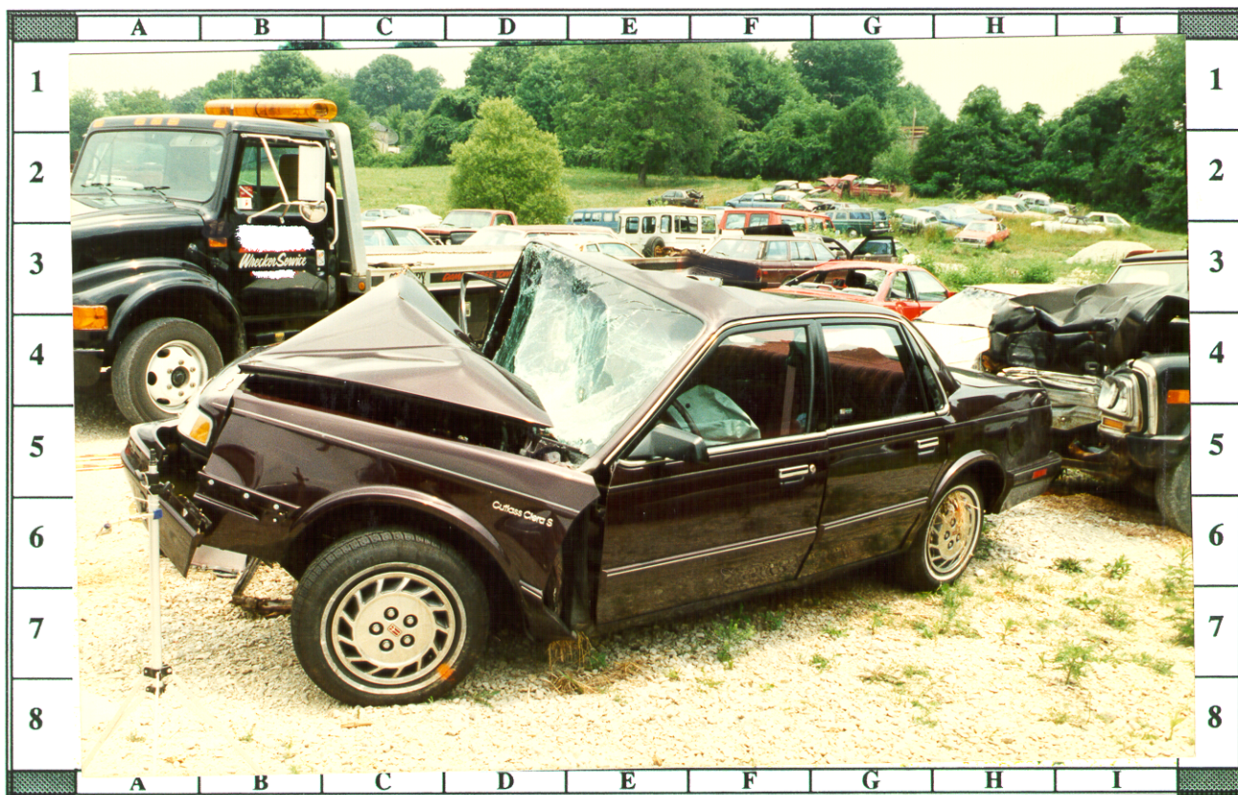
38 -- 1994 Oldsmobile Cutlass Ciera S viewed from left showing frontal rightward shift and induced damage to right A-pillar

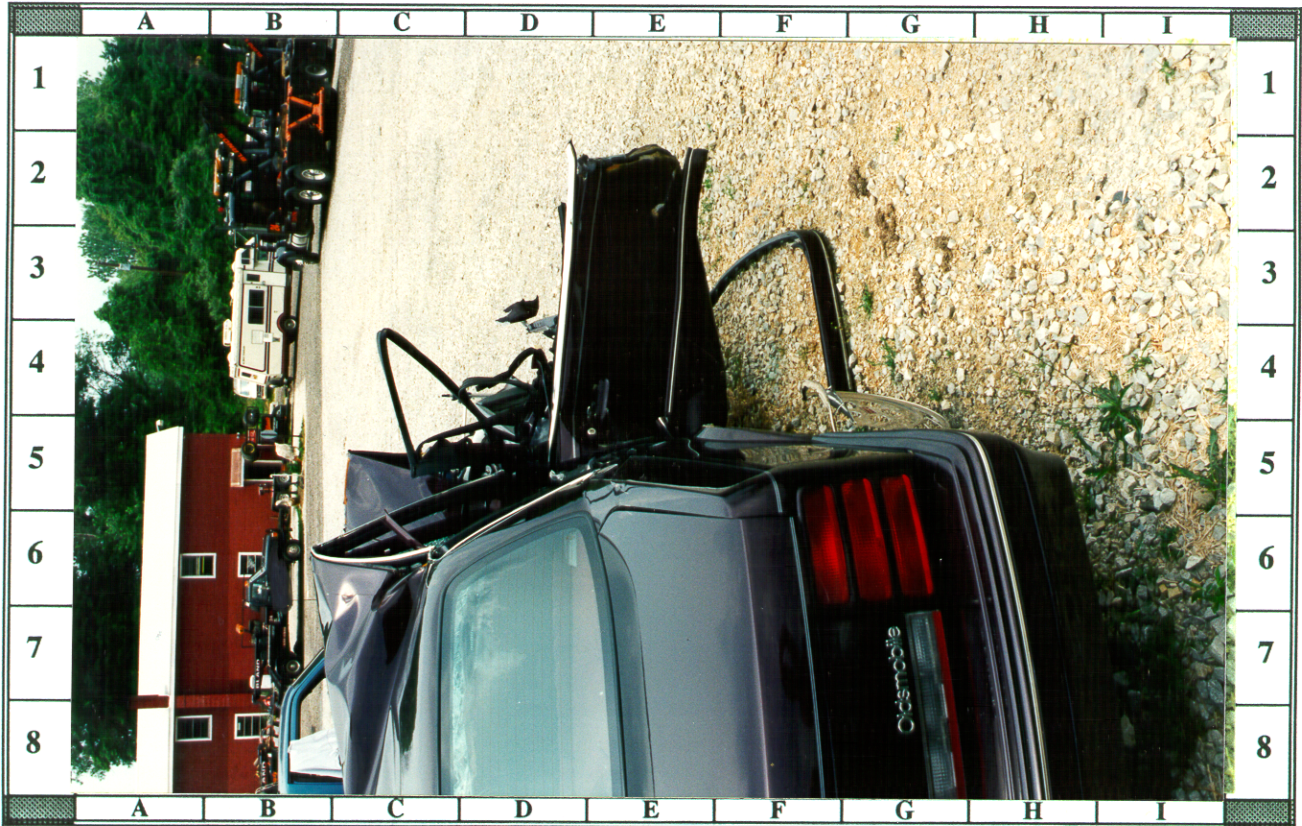
42 -- 1994 Oldsmobile Cutlass Ciera viewed from back along right side showing induced damage to right A-pillar, roof, and RF door

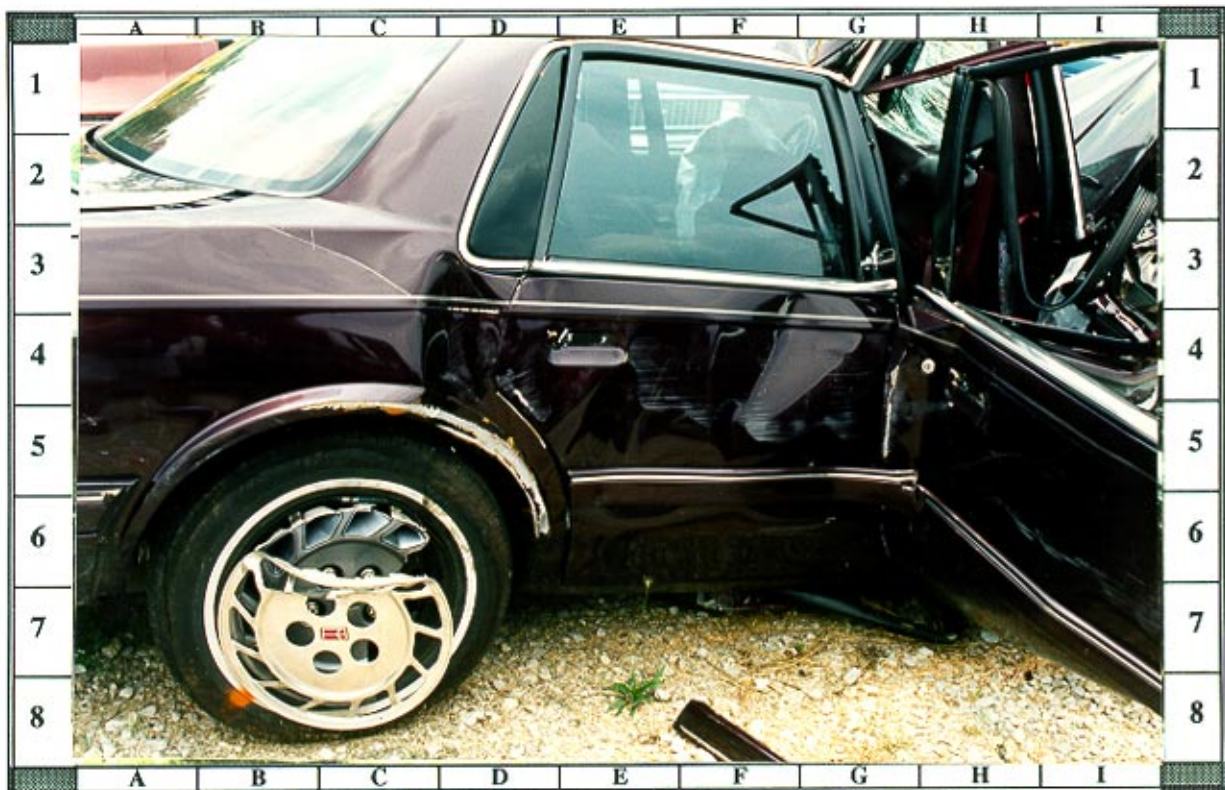
43 -- Close-up of '94 Oldsmobile viewed from right showing right door panels & RR wheel rim & cover damage from sign post impact (3rd)

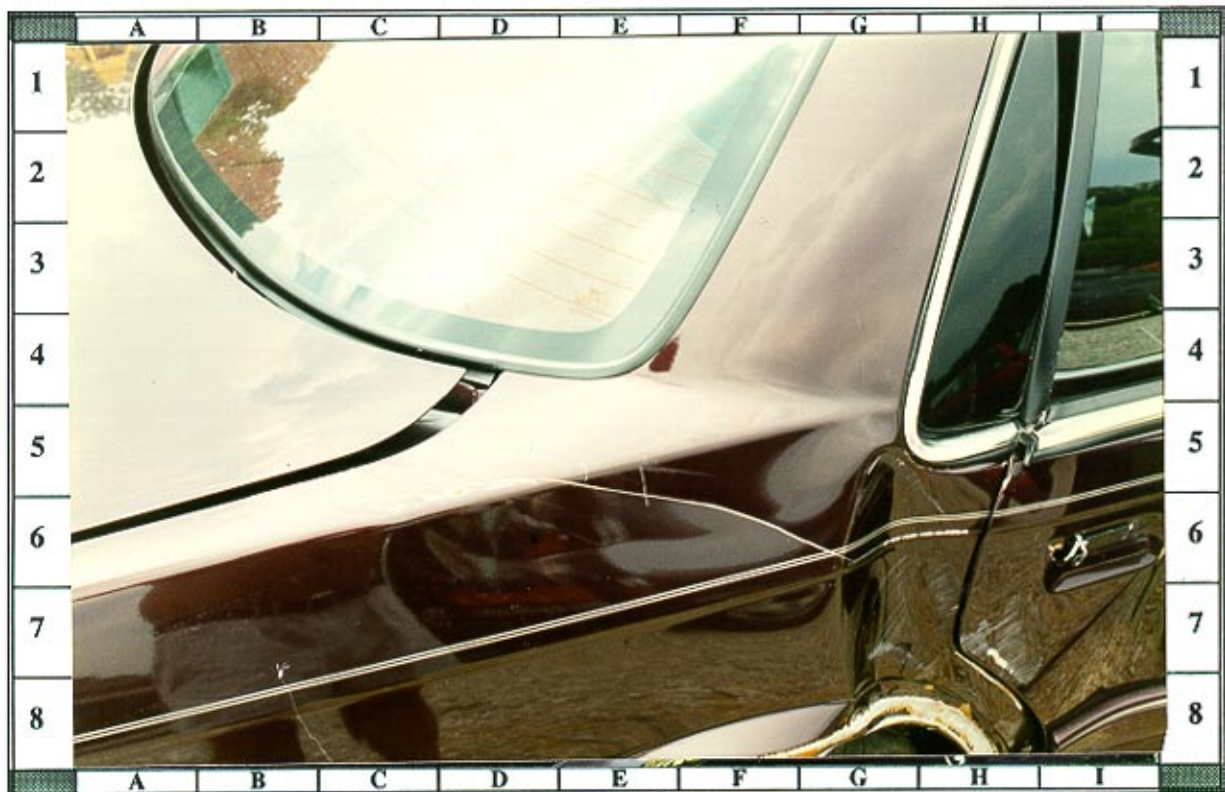
44 -- Closer-up of deep scratch to 1994 Oldsmobile Cutlass Ciera S's right quarter panel from impact (3rd) with subwarning sign

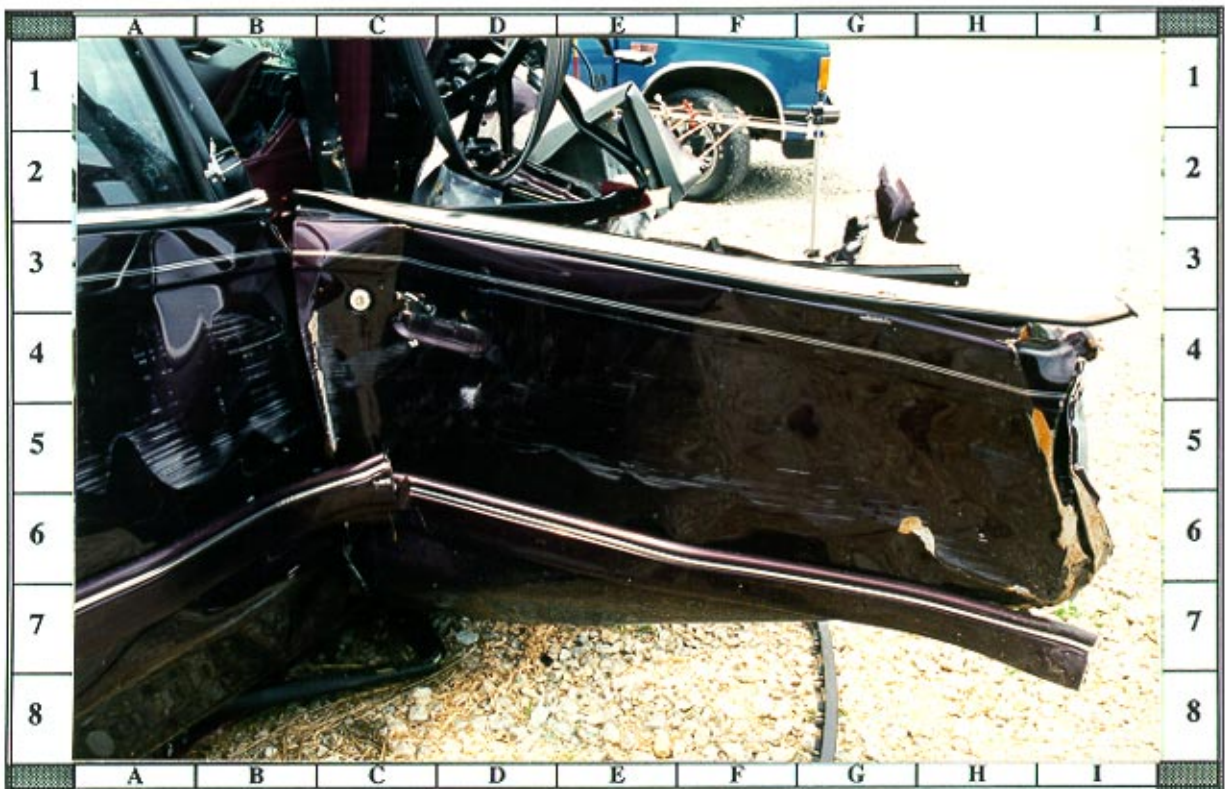
45 -- Close-up of swiping damage to 1994 Oldsmobile Cutlass Ciera S's right front door panel from sign post impact (3rd)

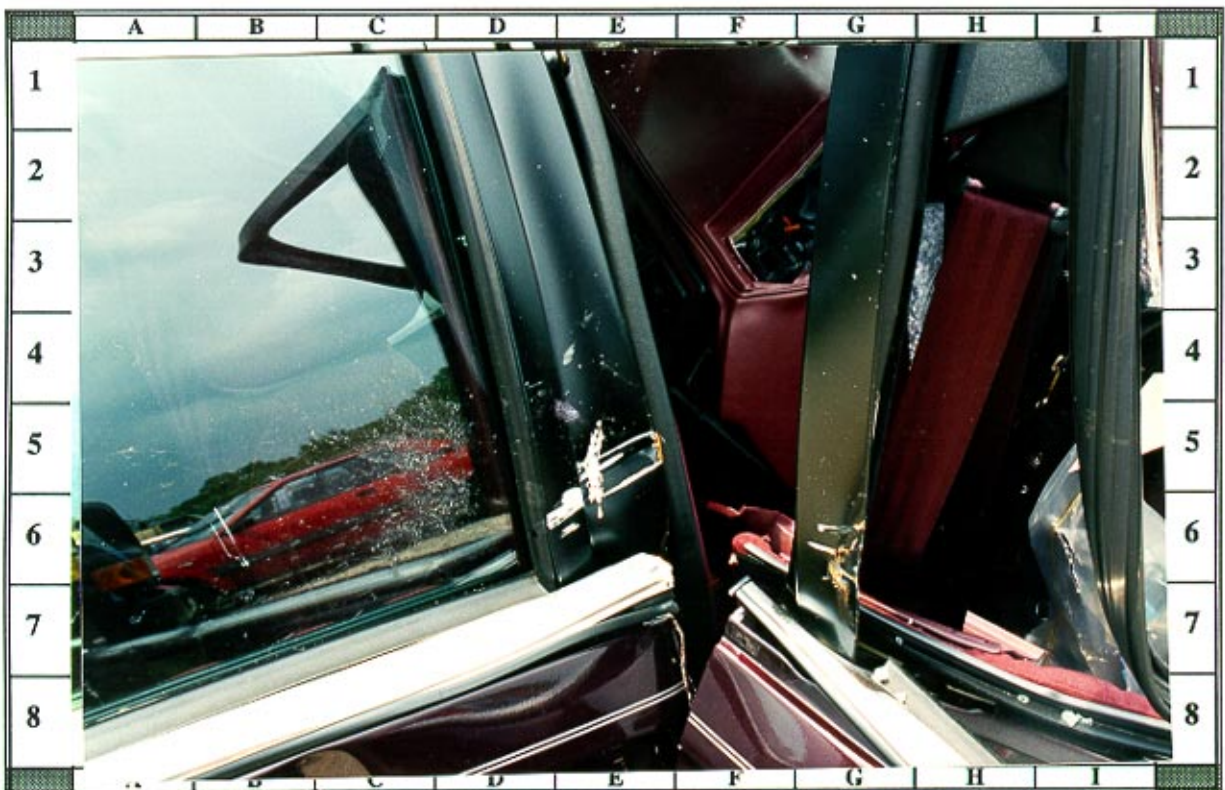
46 -- Scratches to 1994 Oldsmobile Cutlass Ciera's right B-pillar and rear of RF & front of RR window frames from mailbox impact (1st)

¹ The right outside rearview mirror was most likely also involved, but was not available for examination. Therefore, the length of direct damage, the location where the direct began, and the D measurement cannot be determined.

C₅:	Not applicable
C₆:	Not applicable
D:	Unknown¹
Maximum Crush:	2 cm (0.8 in)
Location:	Right "B"-pillar
CDC:	12-RPGS-1
Damaged Components:	Right side door frames, right "B"-pillar, and most likely the right outside rearview mirror

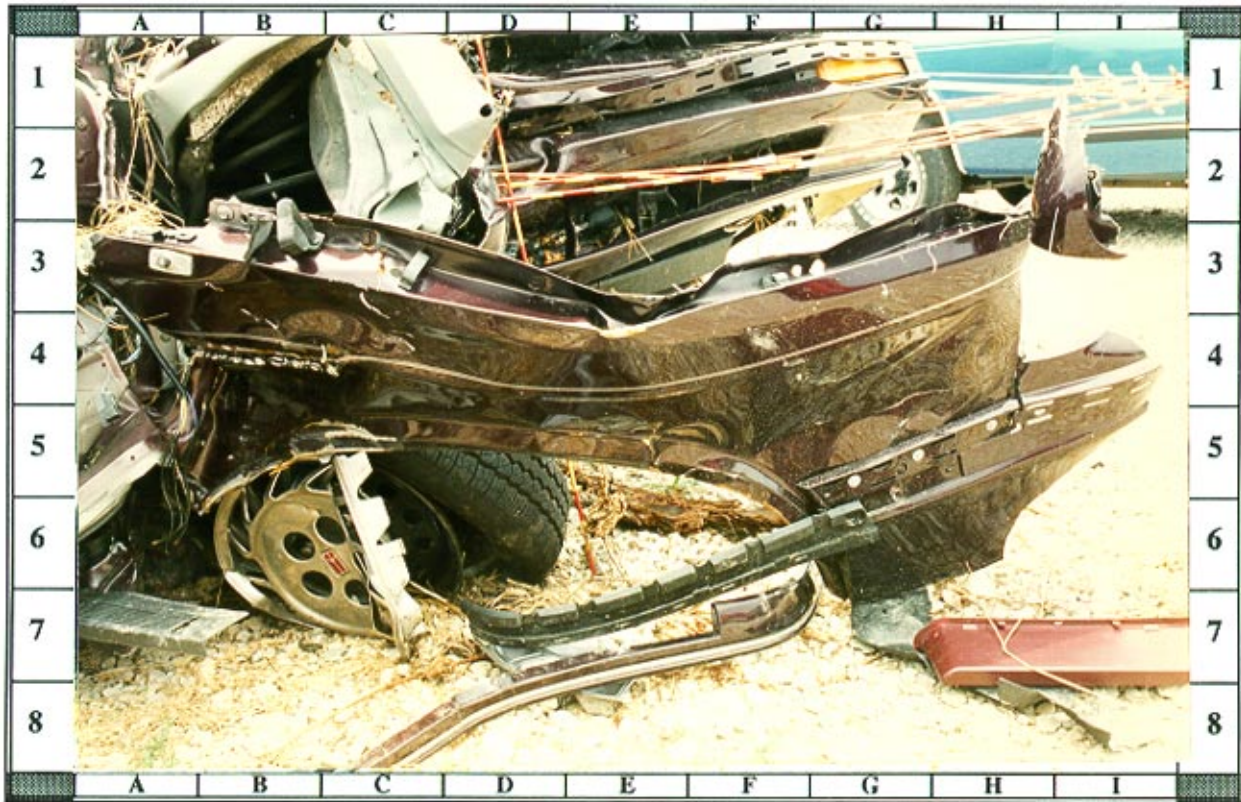
47 -- Close-up of damage to '94 Cutlass Ciera's right fender, wheel, rim, and wheel cover; NOTE: vertical rod represents max crush"

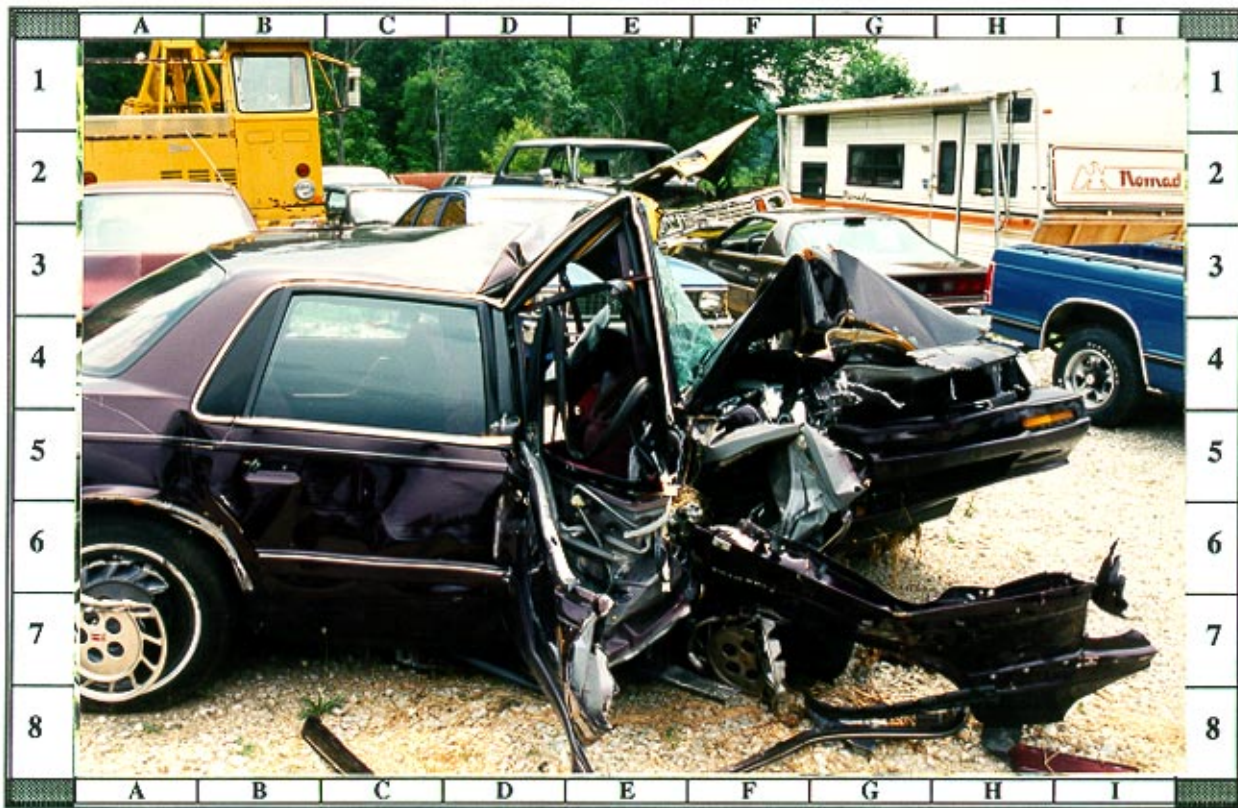
48 -- 1994 Oldsmobile Cutlass Ciera S viewed from right showing extensive frontal crush and intrusion at the right A-pillar area

Damaged Components:	Front bumper, grille, front right headlight assembly, right front wheel assembly and fender, right "A"-pillar, and right uni-body frame
----------------------------	--

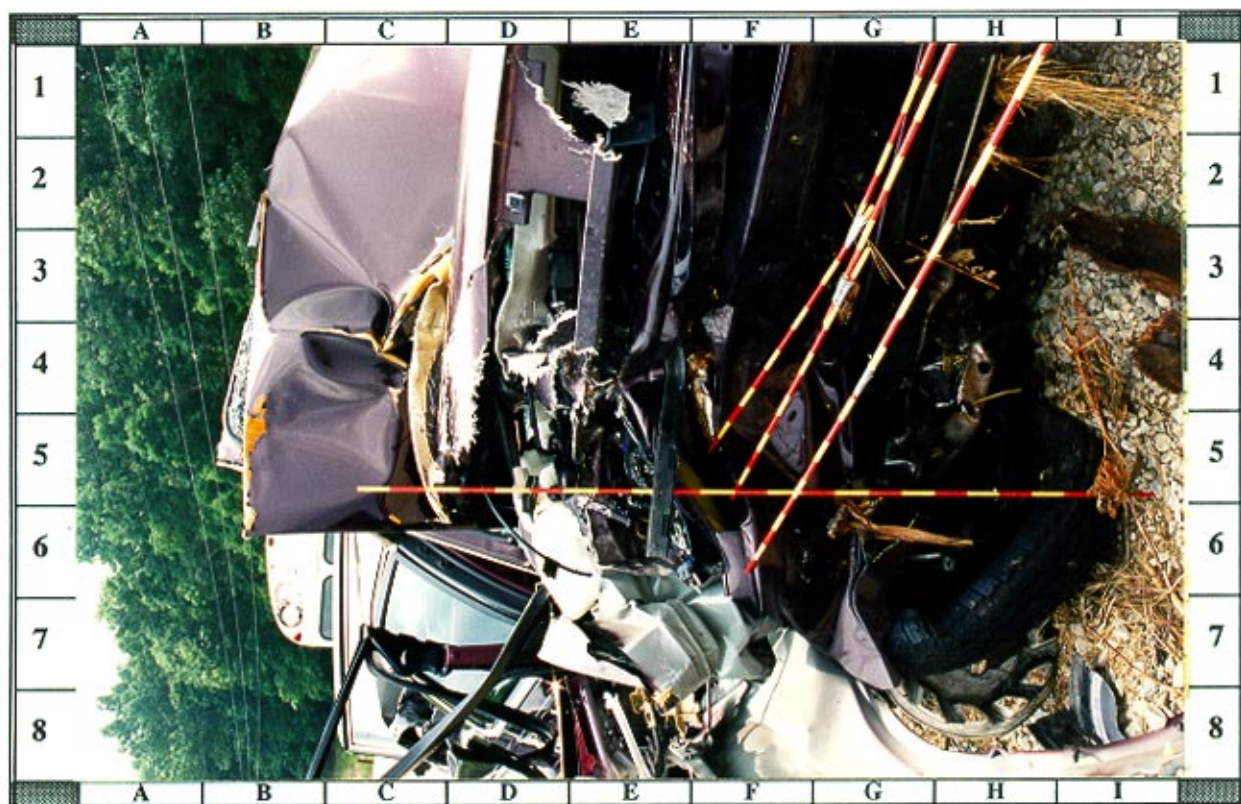
51 -- Close-up of 1994 Oldsmobile Cutlass Ciera S's direct damage at front right corner (i.e., area of maximum crush)

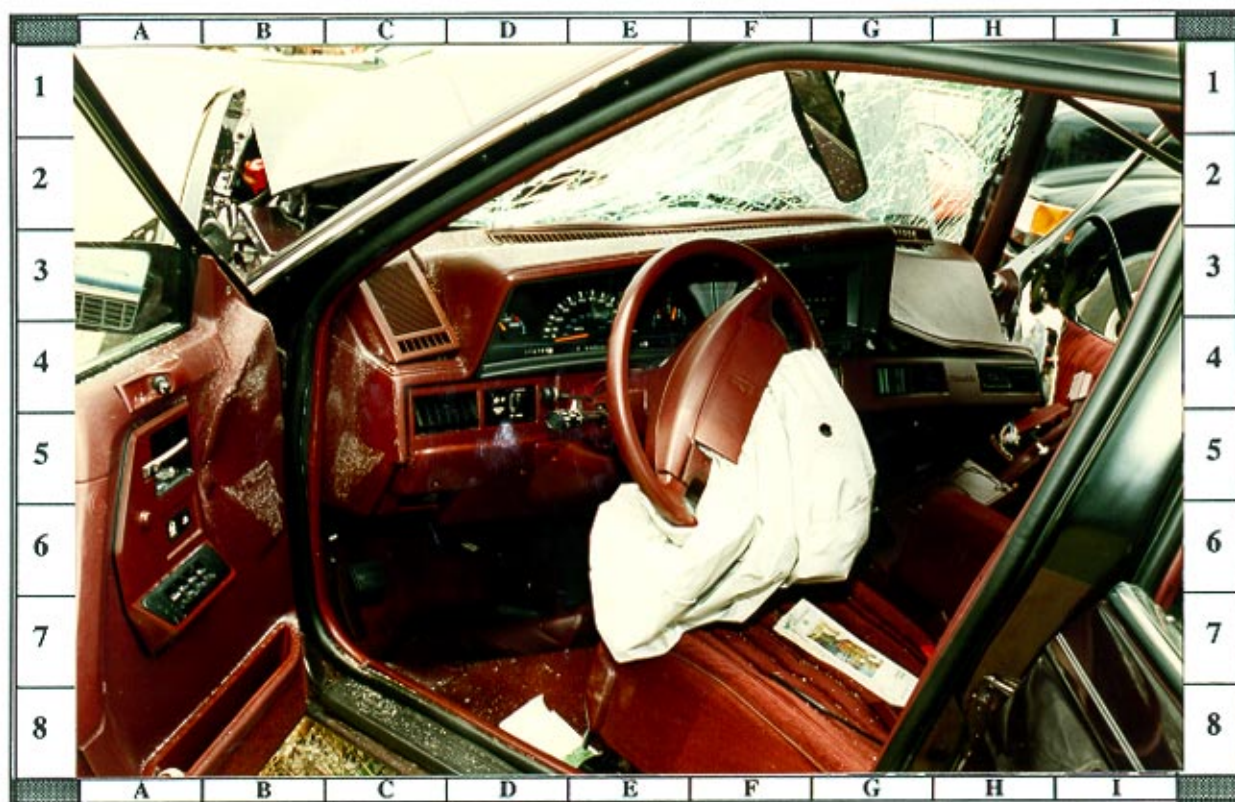
55 -- Driver's area of 1994 Oldsmobile Cutlass Ciera showing deployed air bag and extensive intrusion into right front occupant space

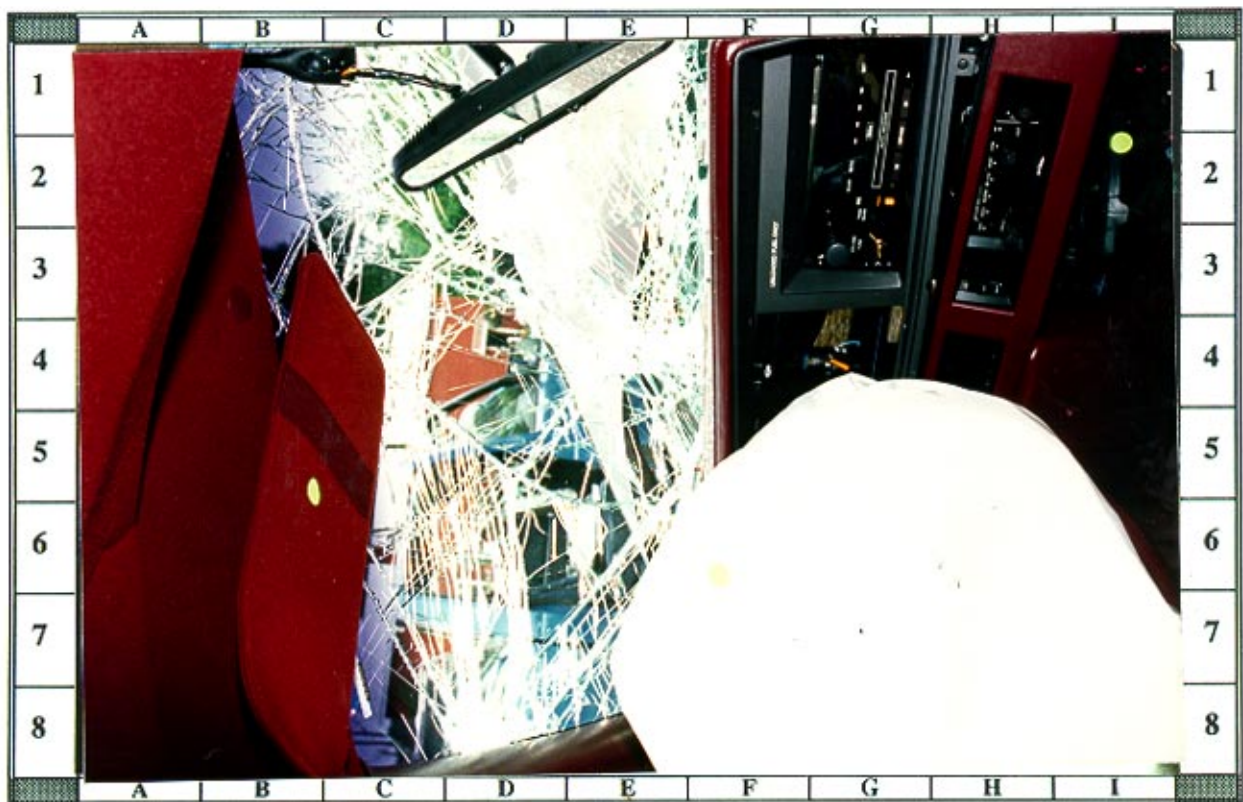
59 -- 1994 Oldsmobile's steering wheel and dash viewed from the right;
NOTE: hair on sunvisor (cell B6) and dash indentation (cell F5)

Left lower dash panel broken out from right knee contact, hair on sunvisor, smudge on left dash, and deployed air bag (see **SELECTED PHOTOGRAPHS**, Photographs # 61, # 59, and # 60, pages 30-31)

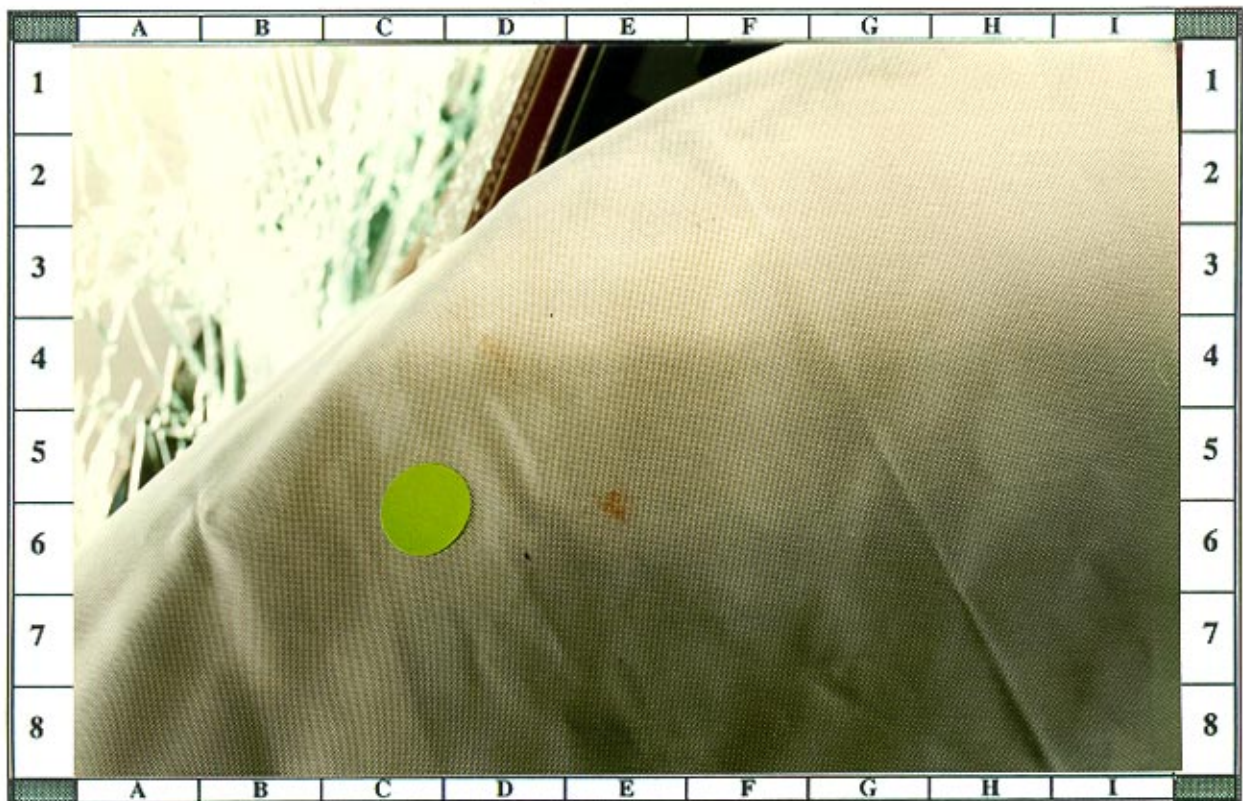
60 -- Close-up of probable facial contact to 1994 Oldsmobile Cutlass
Ciera S's driver air bag

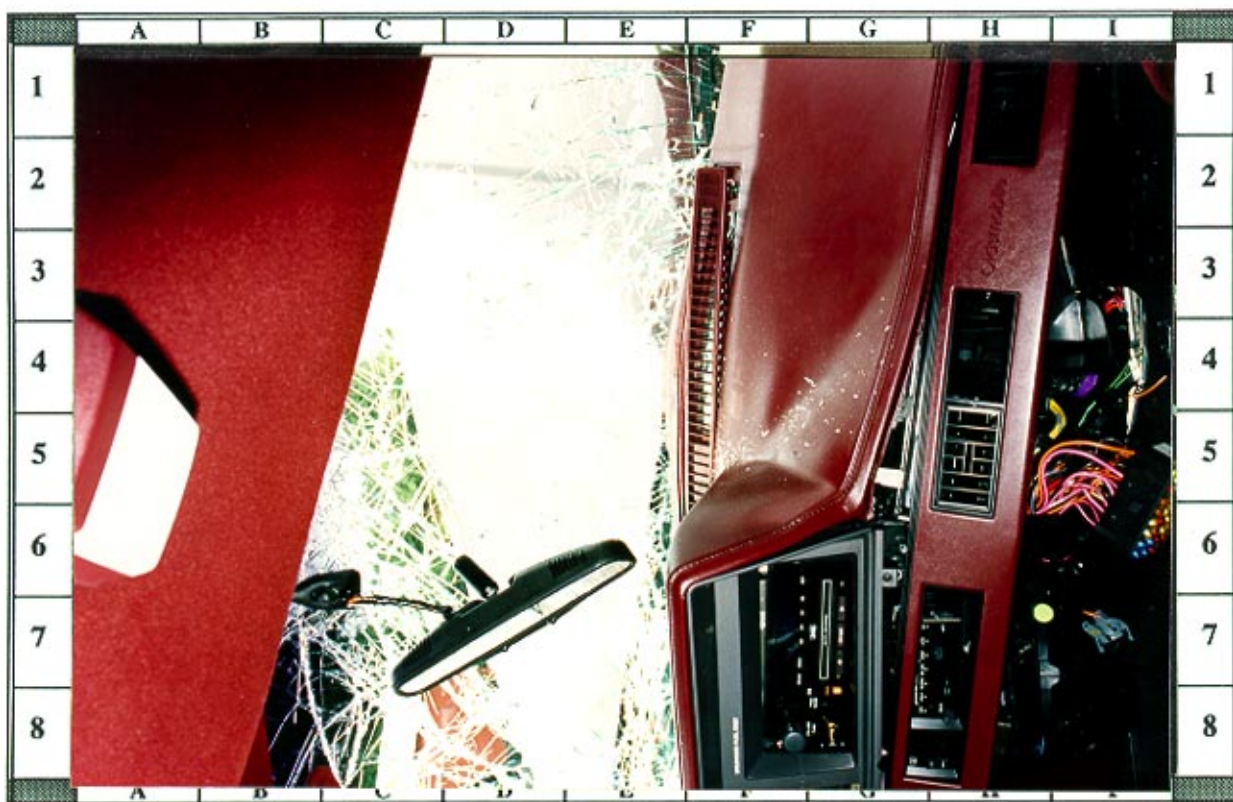
61 -- Close-up of 1994 Oldsmobile Cutlass's left & center dash; NOTE: dash damage, R knee contact (cells H6-I7), & rearview mirror

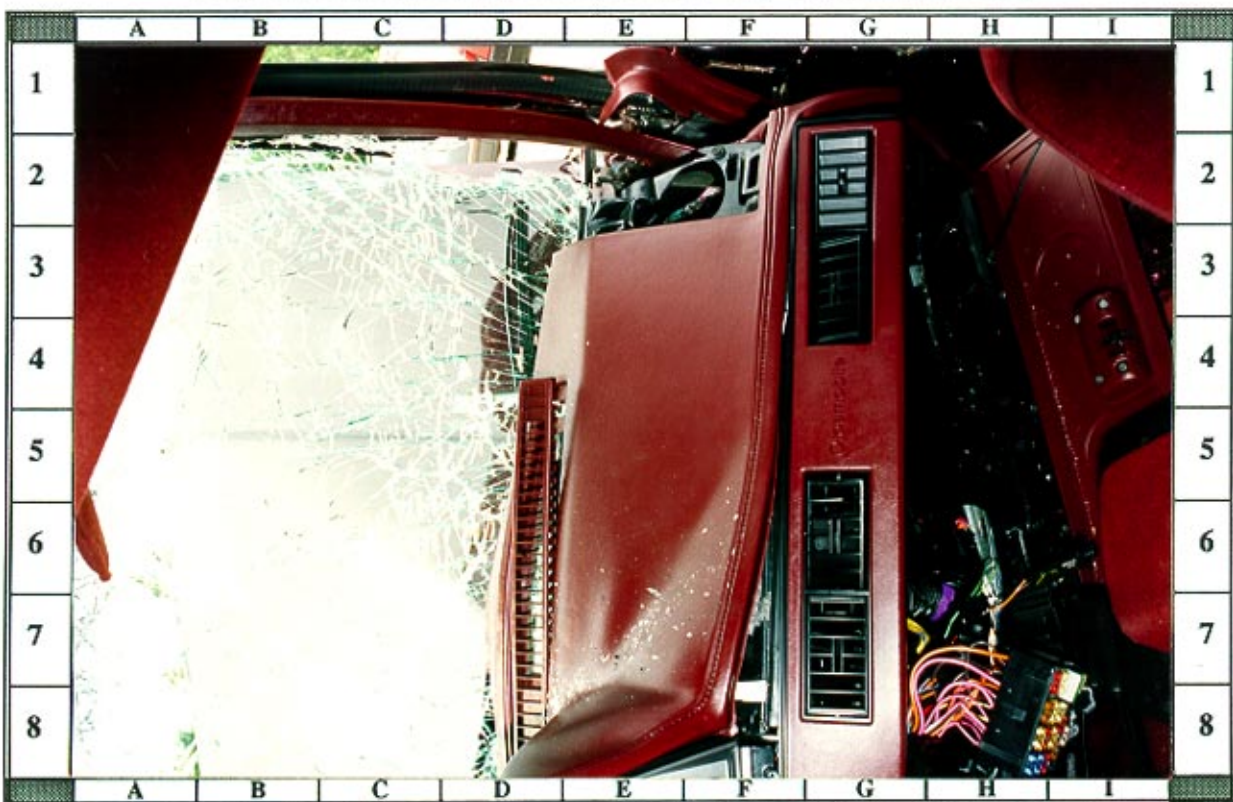
62 -- Close-up of 1994 Oldsmobile Cutlass Ciera S's right dash; NOTE: extensive dash intrusion & glove box & induced windshield damage
